# Midland X-tra Talk Radio LXT118 Front buttons Replacement

Front buttons stuck or misaligned? Let's get them readjusted!

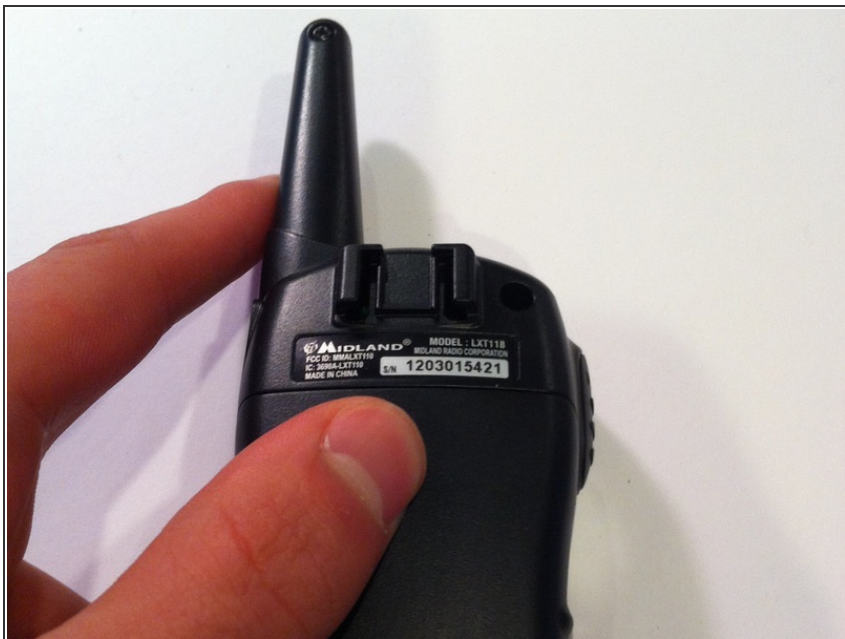
## Step 1 — Batteries

- First, apply pressure with your thumb on the top of the battery cover.

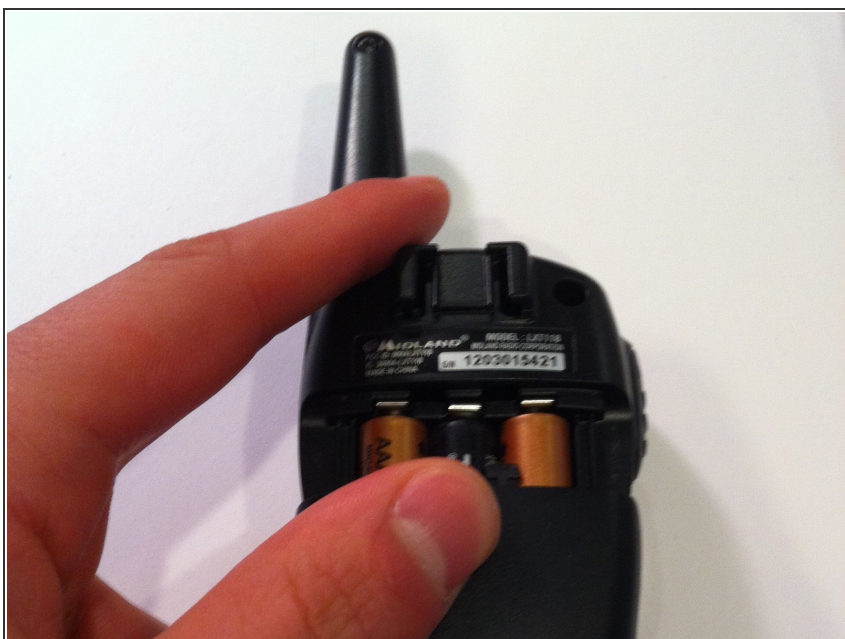
## Step 2

- Next, pull down on the cover until it begins to slide.

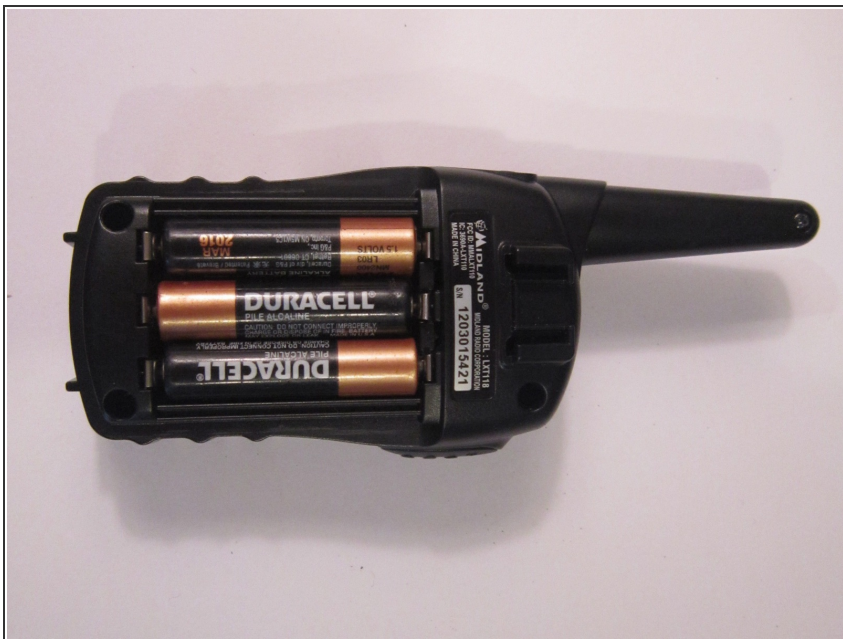
## Step 3

- Finally, once the cover is completely off, pry up the old batteries with your finger or a strong, skinny tool (i.e. spudger).

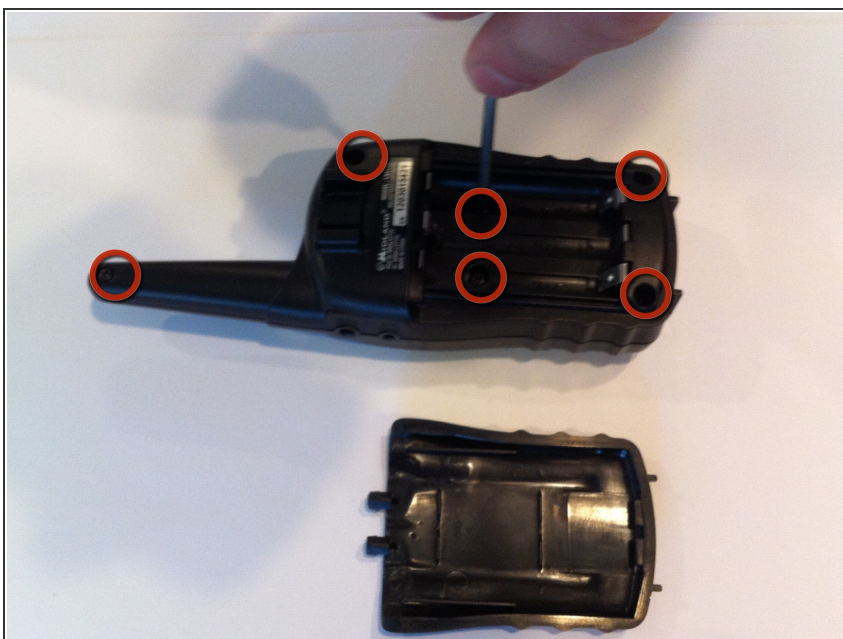
## Step 4 — Case

- Unscrew the six 8.0 millimeter long, #0 screws on the backside of the case using the Phillips #0 screwdriver.

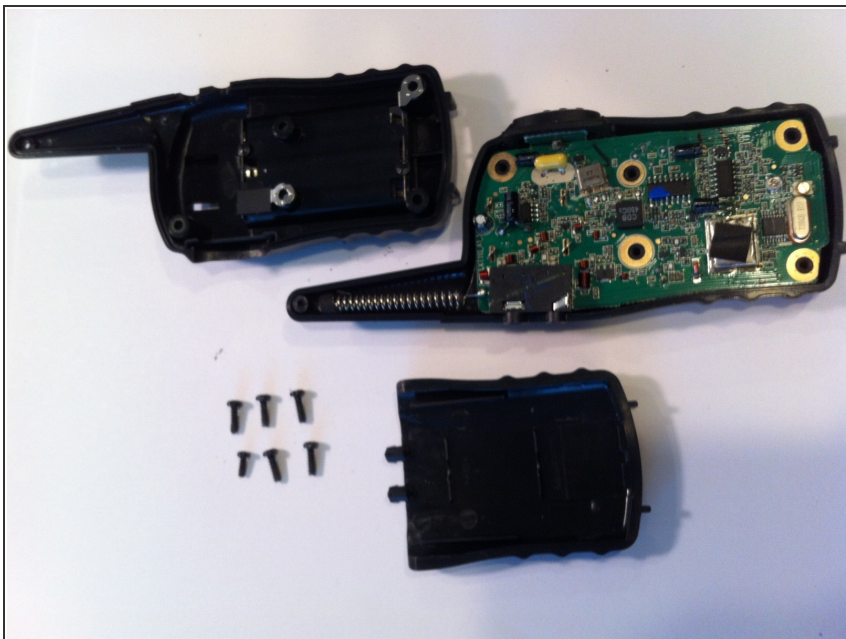
## Step 5

- Detach back part of the case by gently lifting up.

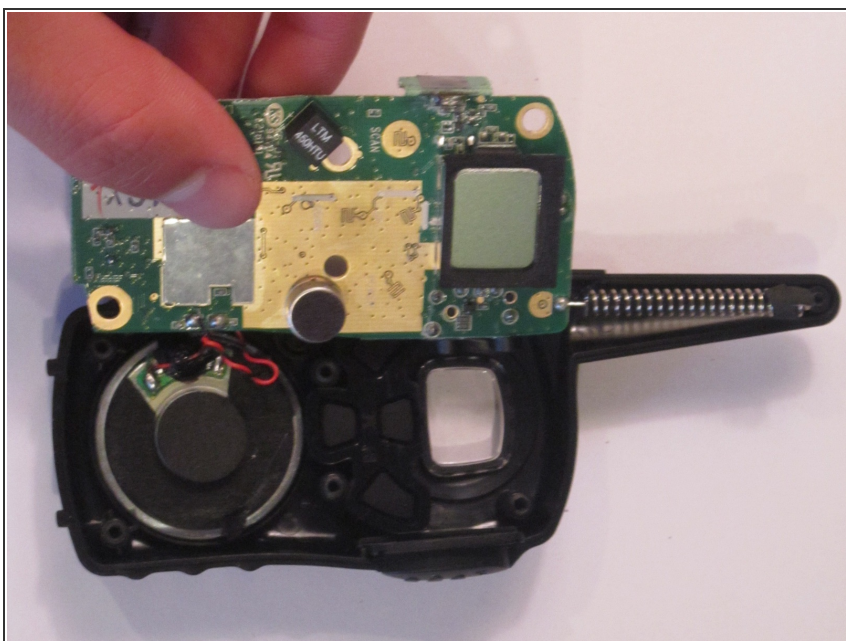
## Step 6 — Front buttons

- Once the back case is already off, use your fingers to lift up the circuit board from the side opposite the antenna.

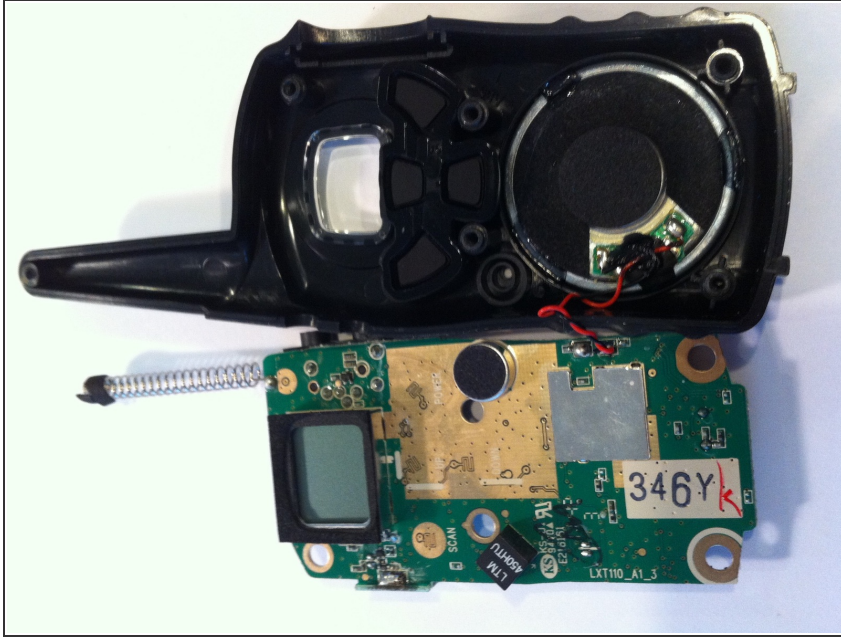
## Step 7

- Lay the circuit board down on the side, as you will not want it interfering with your work on the buttons!

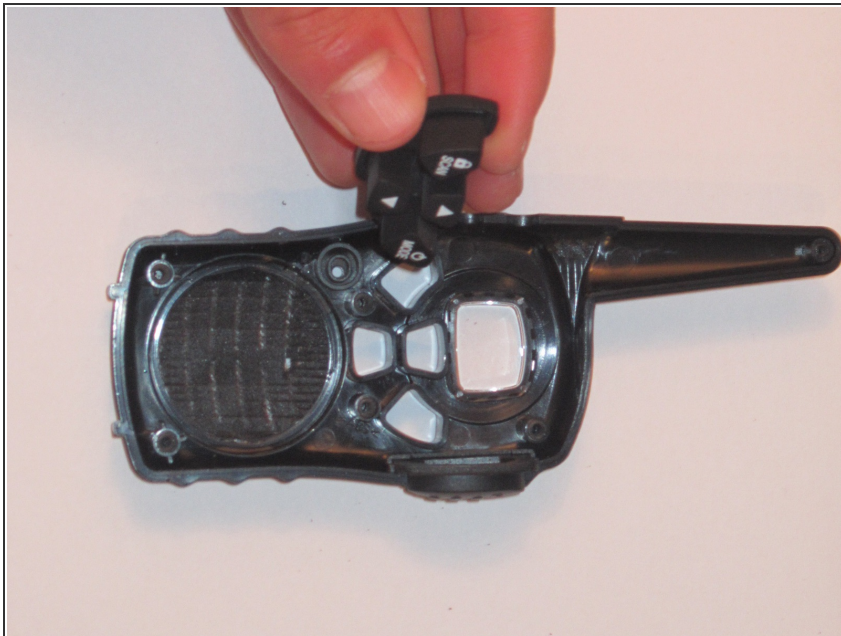
## Step 8

- Grasp the rubber cast around the buttons from one side, and slowly lift upwards. Make note of which way the buttons fit into the plastic casing!
- At this point, the buttons can be cleaned in accordance with the [radio buttons are stuck or sticking](#) troubleshooting guide.
- ❗ The speaker does not need to be removed in order to get to the buttons.

To reassemble your device, follow these instructions in reverse order.
